# Planning Permission

Mambakkam, VANDALUR taluk  
Chengalpattu district, Tamil Nadu

APPROVAL TYPE  
**Building Plan**

NOTE :  
IN COMMERCIAL PLOT VIA  
D.T.C.P. APPROVED LAY OUT NO.  
7 / 2024 , IN S.NO. 168 / 1 OF  
MAMBAKKAM VILLAGE ,  
VANDALUR TALUK ,  
CHENGALPATTU DISTRICT .

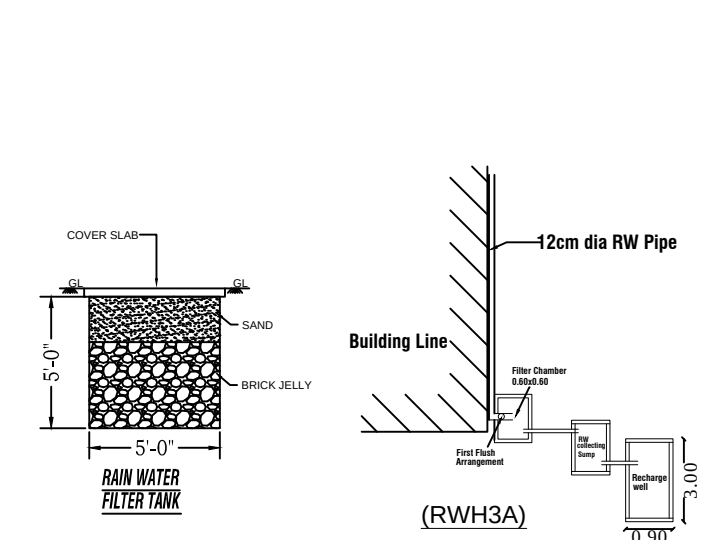
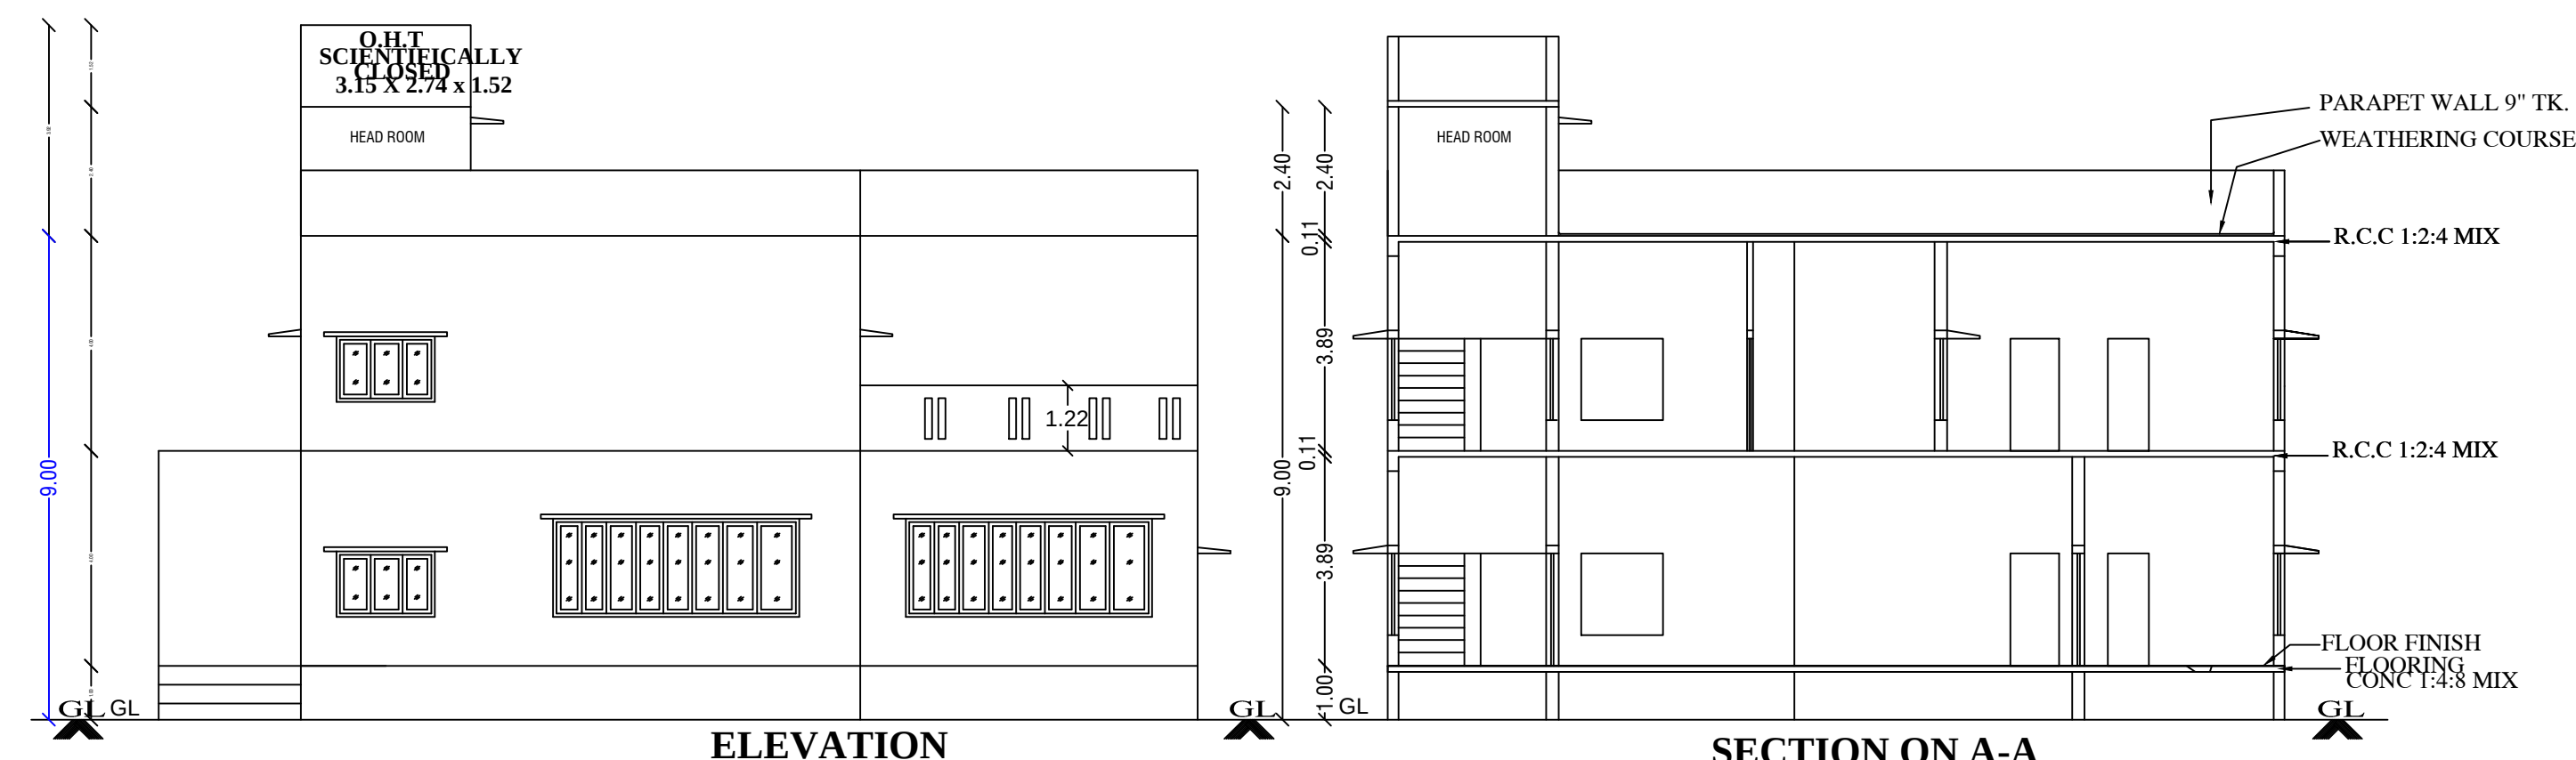
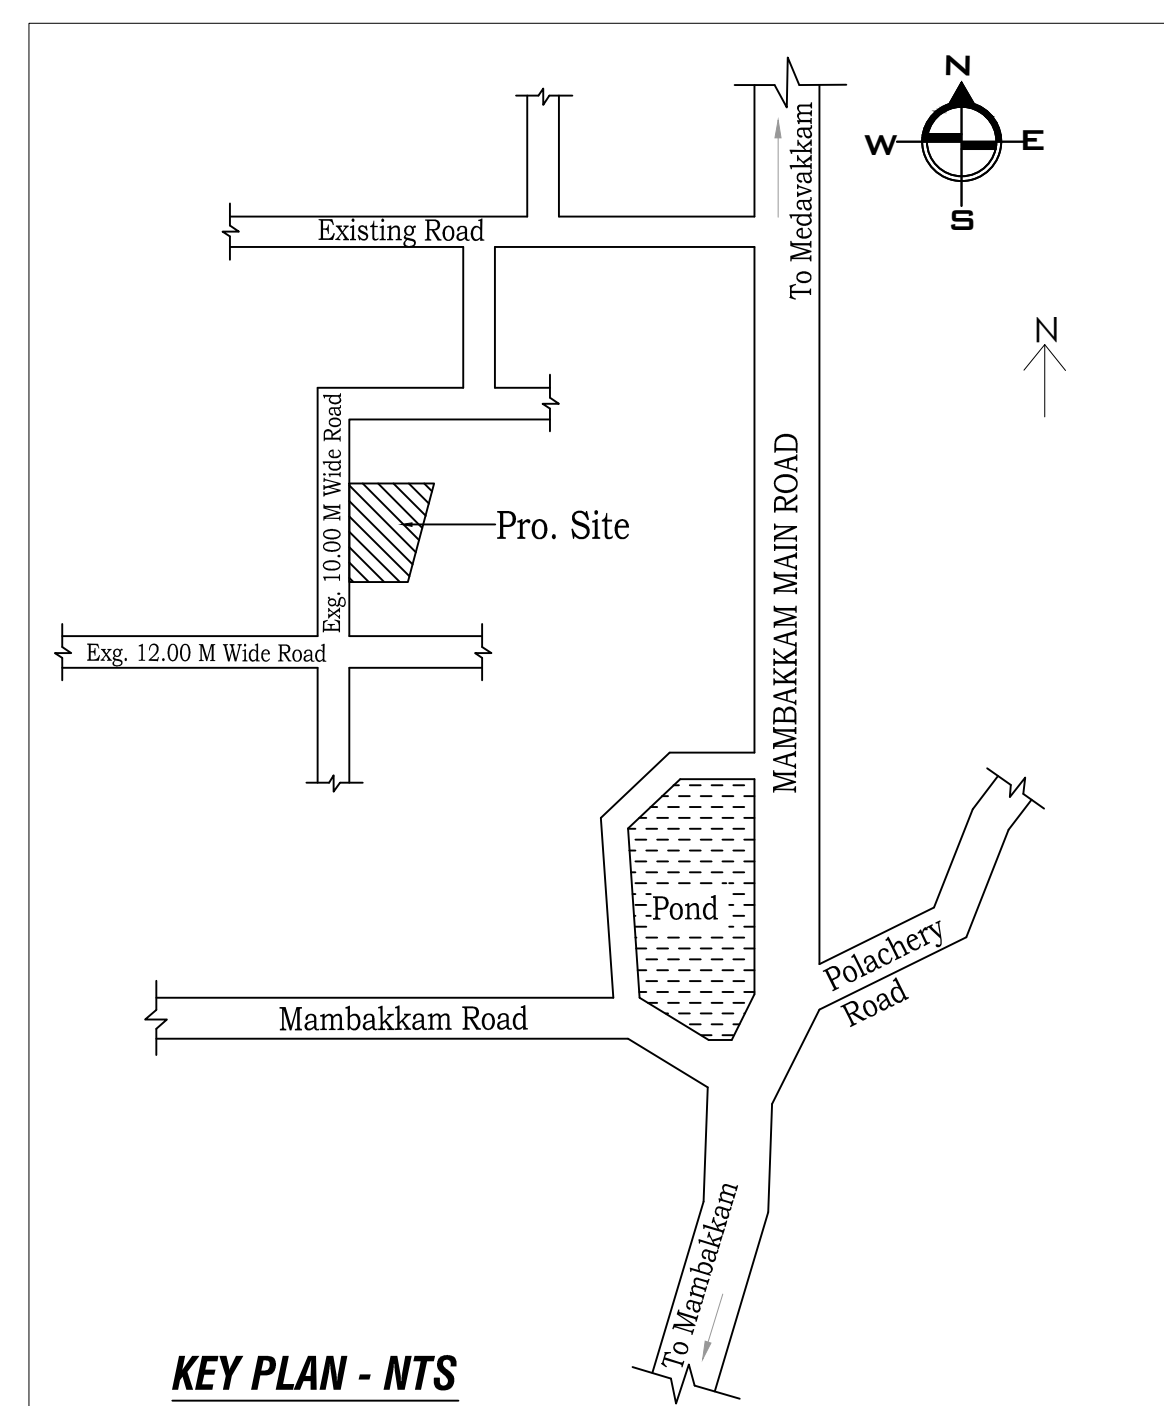
The diagram illustrates the rainwater filtration and storage system. On the left, a cross-section of the **RAIN WATER FILTER TANK** is shown, which is a square unit measuring 5'-0" by 5'-0". It features a **COVER SLAB** on top, followed by a layer of **SAND**, and then a layer of **BRICK JELLY** for filtration. The bottom of the tank is labeled **RAIN WATER FILTER TANK**. To the right, a **12cm dia RW Pipe** connects the filter tank to a **Storage Tank**. The pipe passes through a **Building Line** and includes an **Other Chamber (400mm)** and a **Flow Direction** arrow. The **Storage Tank** is a rectangular unit measuring 3.00m in height and 0.70m in width. The entire system is labeled **(RWH3A)**.
