# Planning Permission

Thottanuthu  
Dindigul district, Tamil Nadu

APPROVAL TYPE  
**Building Plan**

.PLAN SHOWING THE PROPOSED CONSTRUCTION OF THE DWELLING HOUSE BUILDING IN PLOT NO:33, OLD S.NO:- 432/2A, NEW S.NO:- 432/2A1A1A (AS PER DOCUMENT), PATTa NO: 8226 S.NO:432/26B AT METTUR, THOTTANUTHU VILLAGE AND PANCHAYAT, DINDIGUL PANCHAYAT UNION, DINDIGUL EAST TALUK, DINDIGUL DISTRICT.

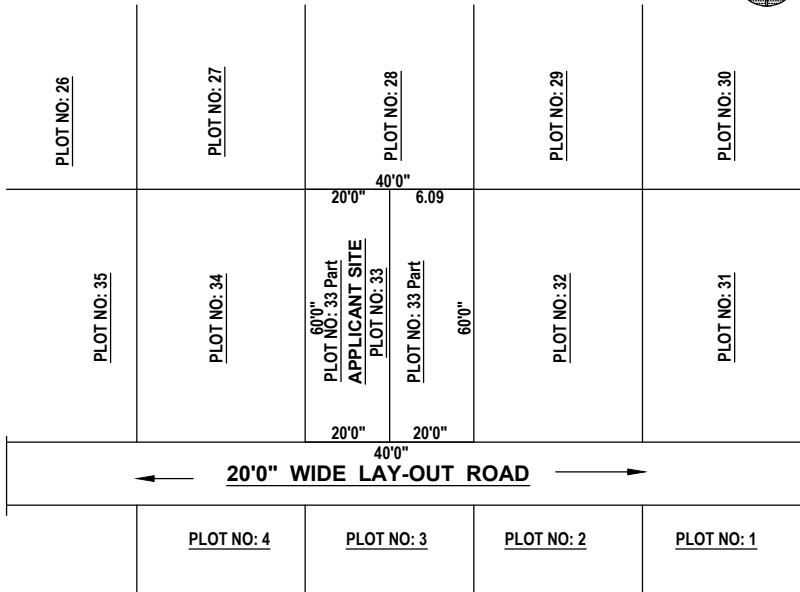
. KEY PLAN .

. REFERENCE  
○ . APPLICANT SITE.  
○ . PROPOSED BUILDING.
