# Planning Permission

PLAN SHOWING THE PROPOSED CONSTRUCTION OF R.C.C ROOF GROUND & FIRST FLOOR BUILDING FOR RESIDENTIAL PURPOSE

IN R.S.F.NO : 295 / 2A, ( OLD S.F. NO : 193 , 199 ), NOW NEW SUB DIVISION NO : 295 / 2B, PATTA NO: 109,

AT SATHYA NAGAR , PARUVACHI - AMMAN PALAYAM ROAD , PARUVACHI VILLAGE & PANCHAYAT, BHAVANI PANCHAYAT UNION ,

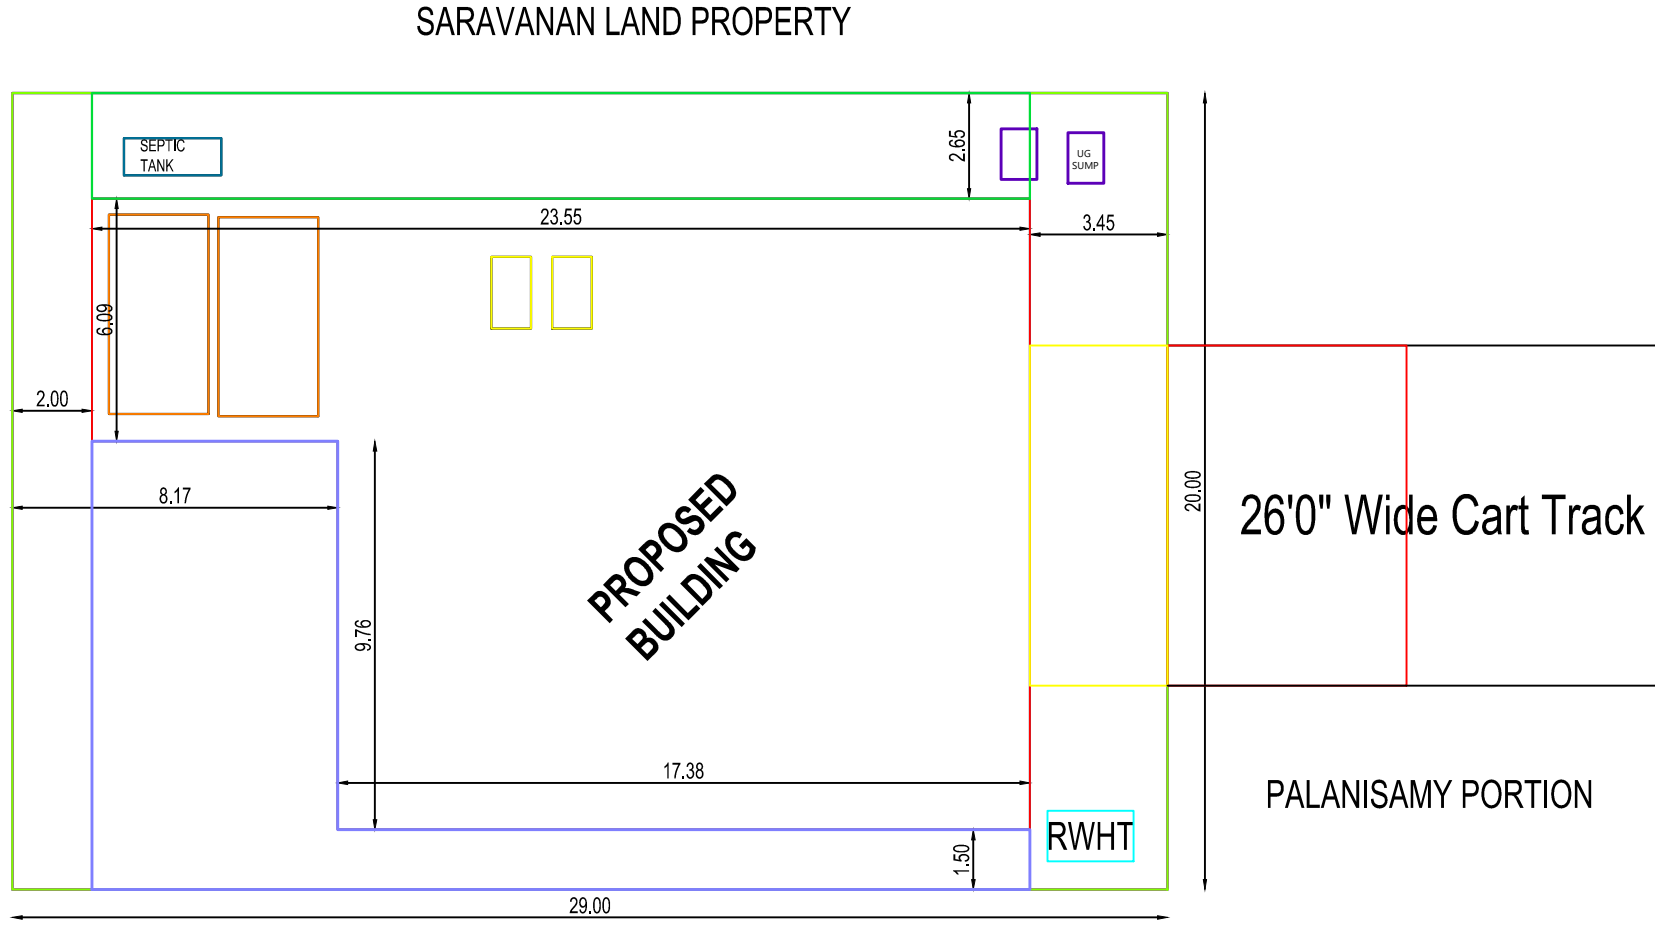
SITE PLAN  
( Scale : 1:100)

ALL DIMENSIONS ARE IN FEET & METRE
