# Planning Permission

PLAN SHOWING THE PROPOSED CONSTRUCTION OF R.C.C ROOF RESIDENTIAL BUILDING AT APPATTUVILAI

AFTER DEMOLISHING THE EXISTING DOOR NO: 6/177/A, IN RE.SY.NO:440/23, OF CHADAYAMANGALAM VILLAGE , IN CHADAYAMANGALAM VILLAGE PANCHAYAT, KALKULAM TALUK, KANNIYAKUMARI DISTRICT.

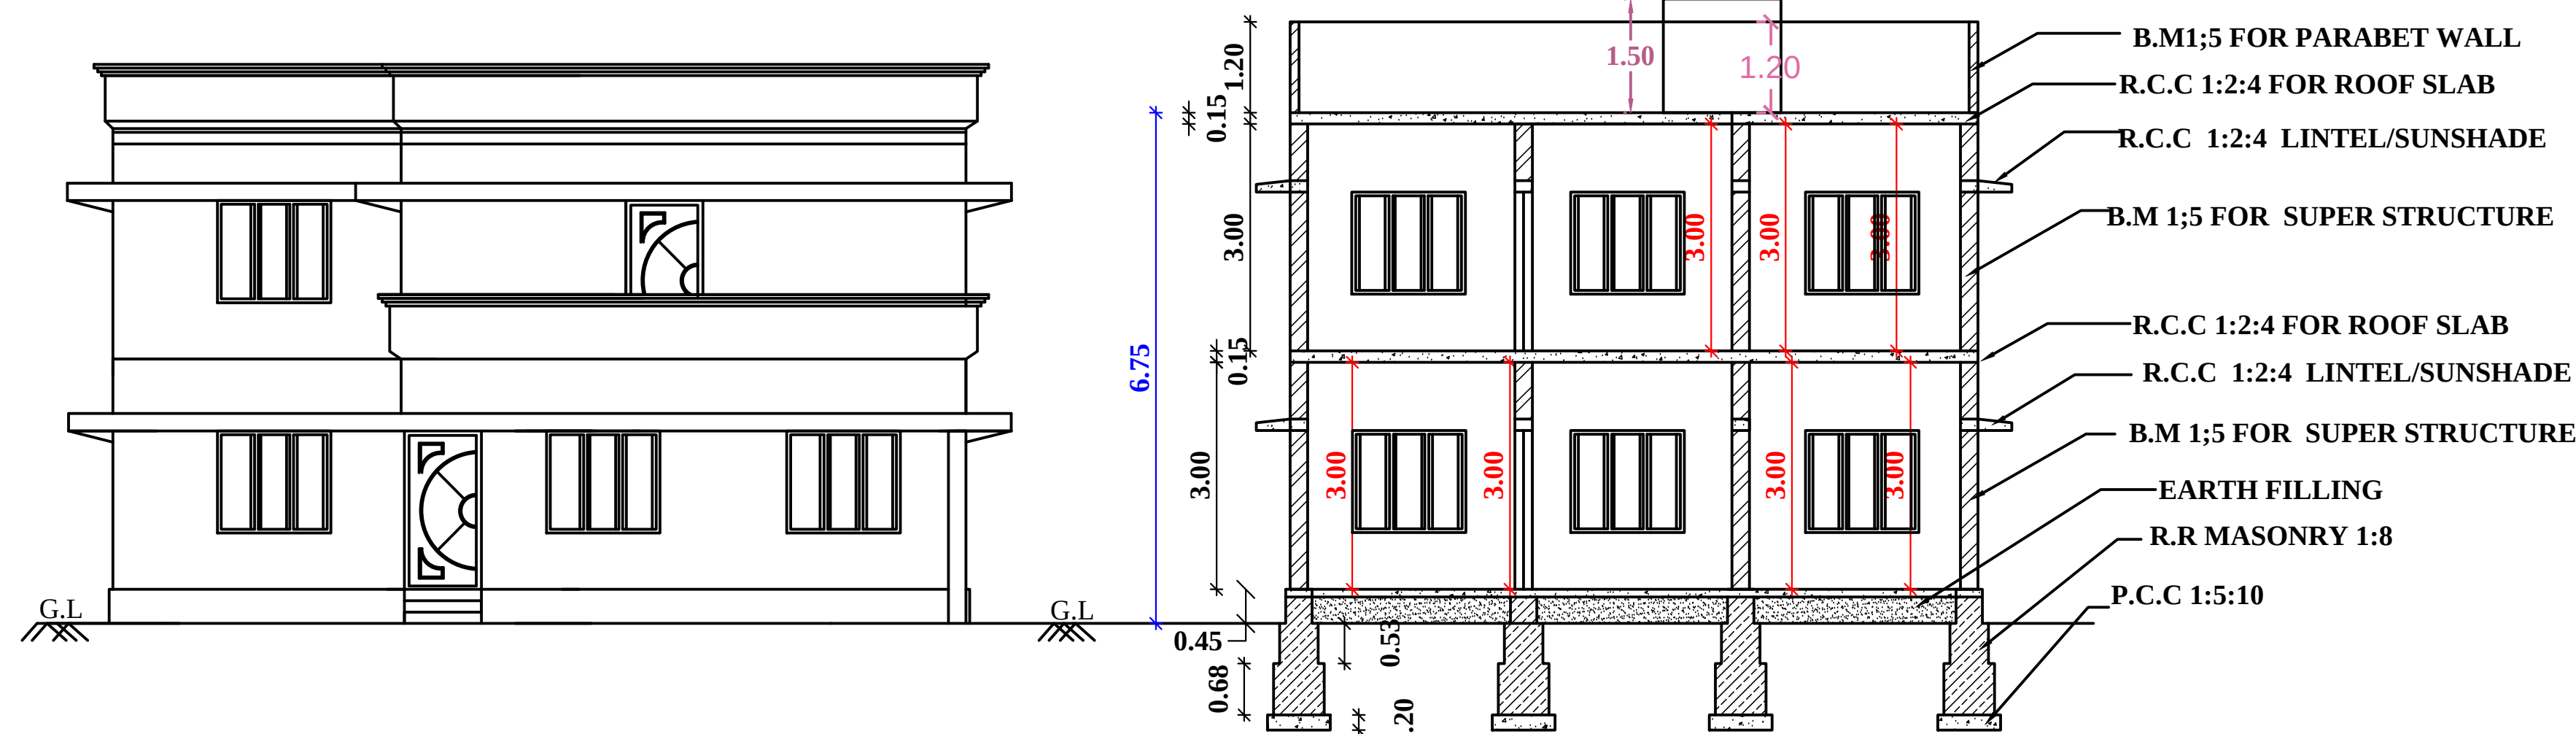
ELEVATION

SECTION ON 'AB'

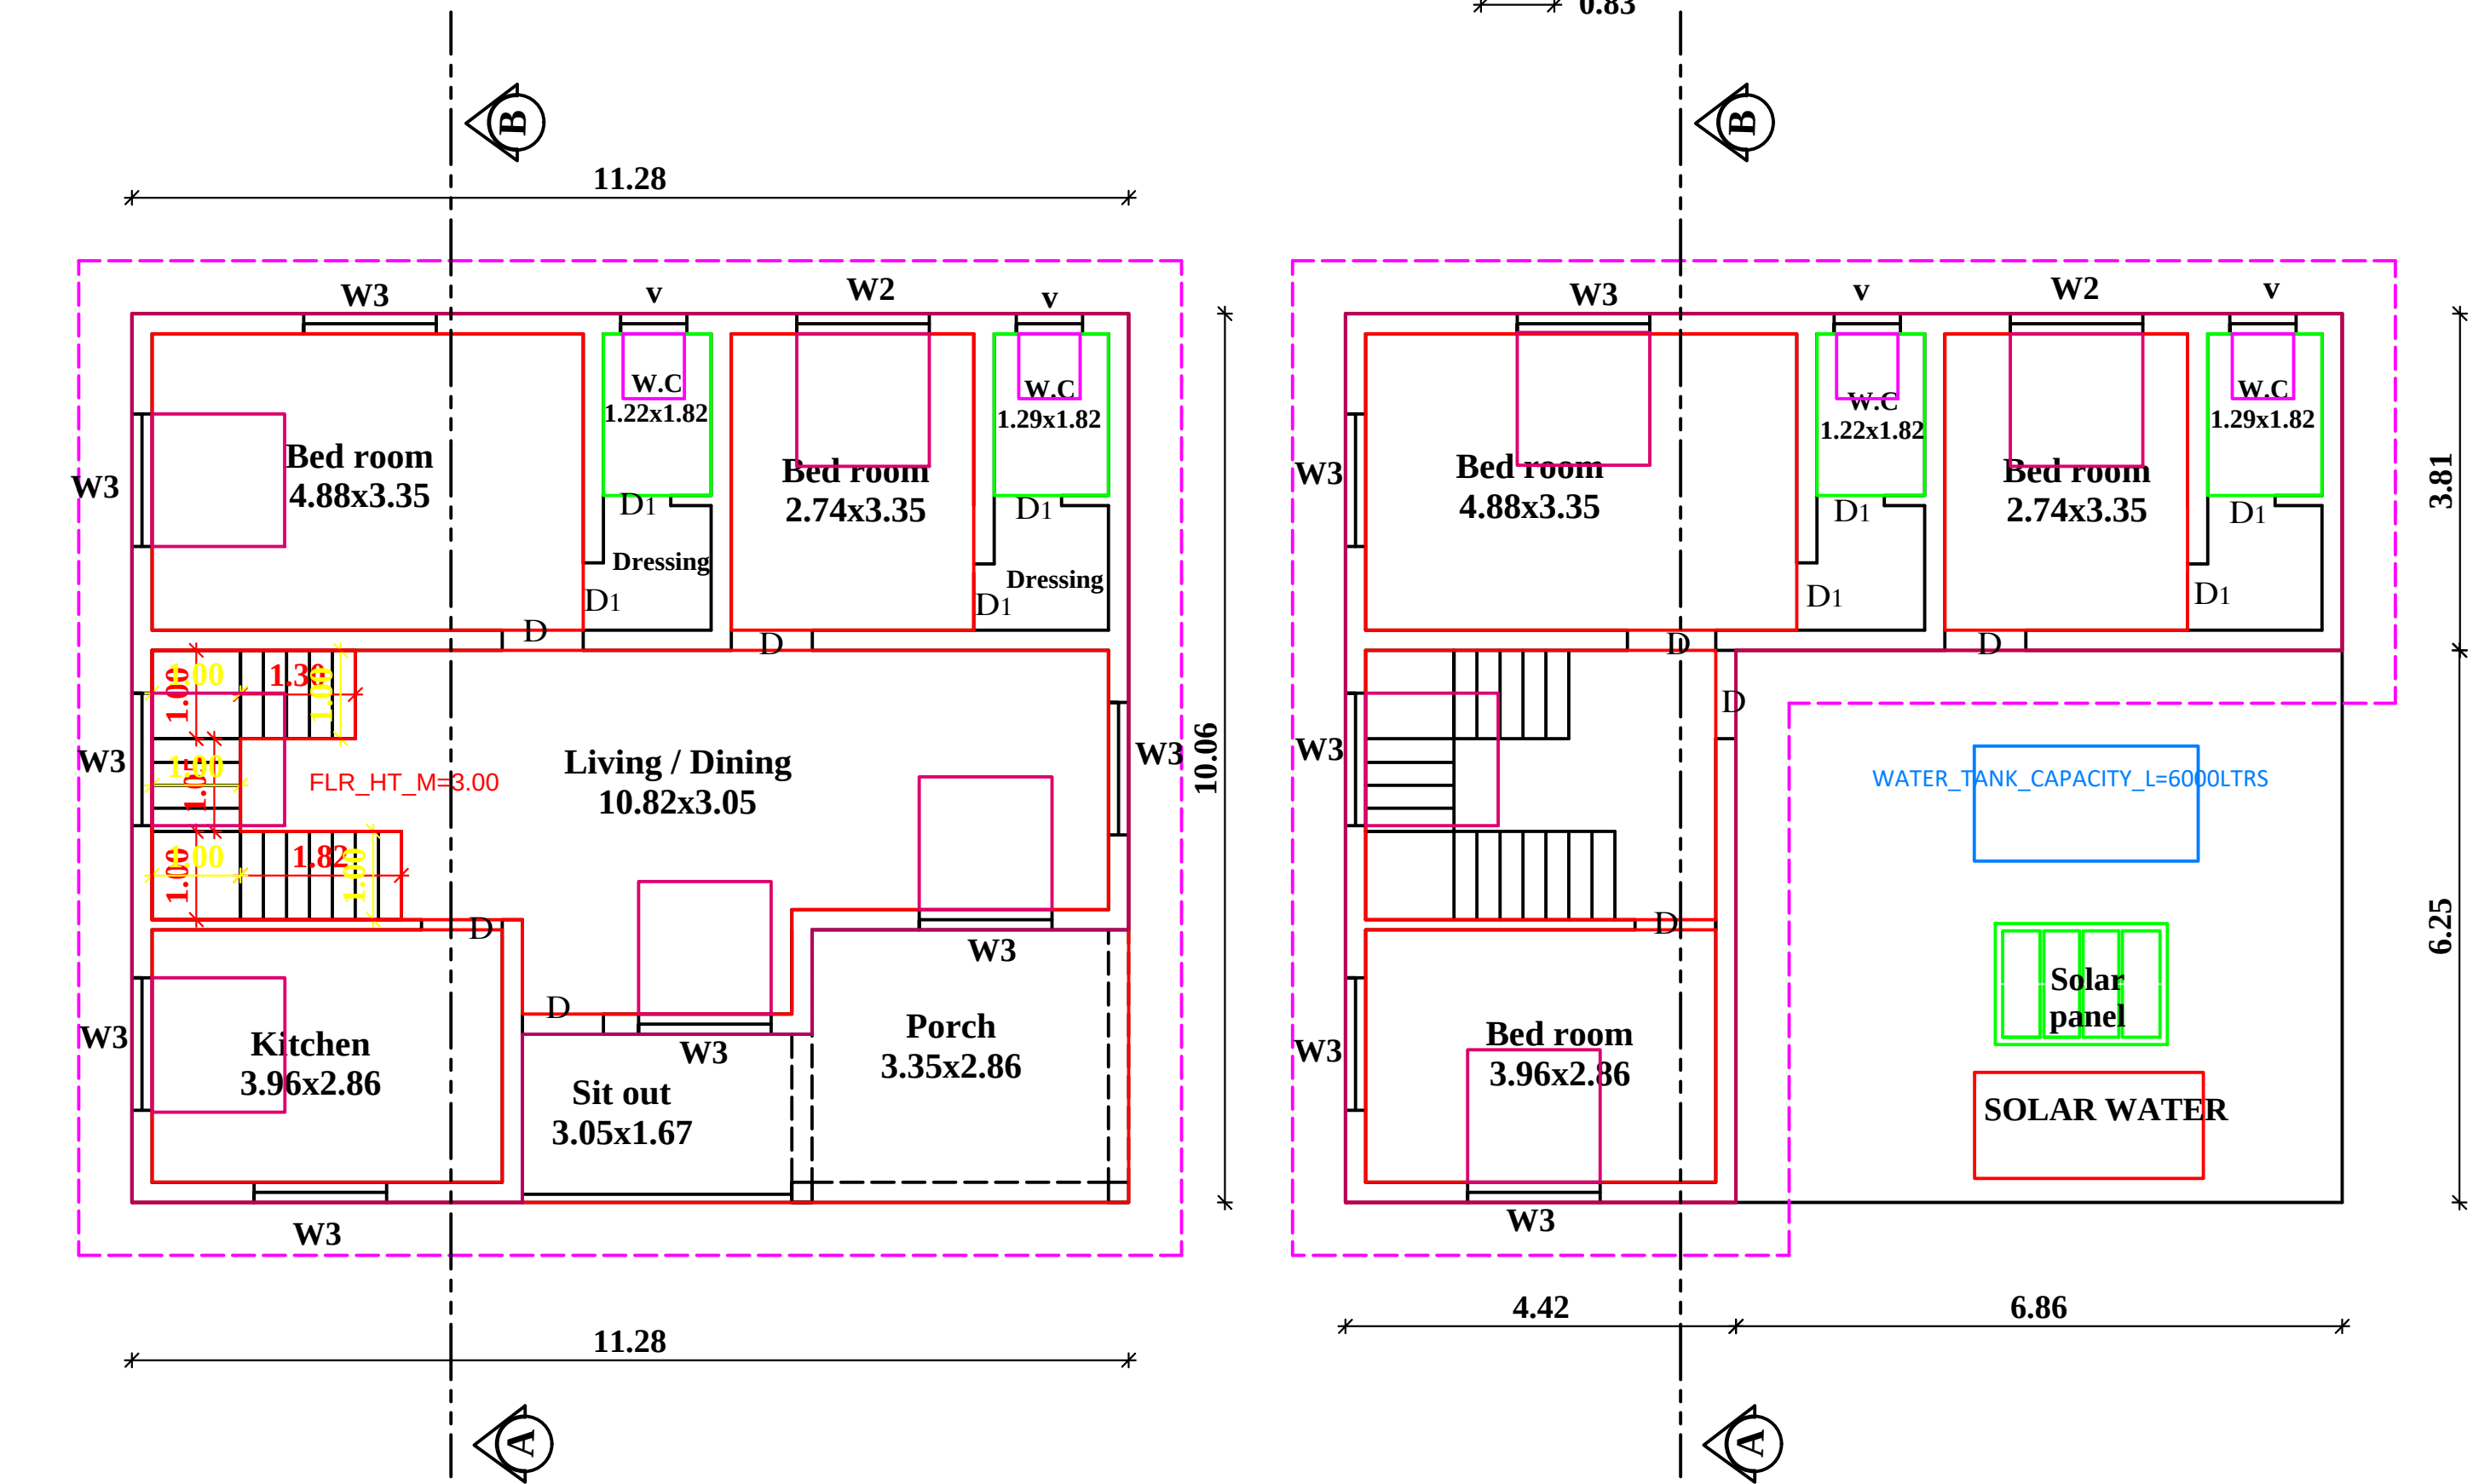
GROUND FLOOR PLAN

FIRST FLOOR PLAN
