# Planning Permission

**Building Plan**

**Rural Panchayat**

PLAN SHOWING THE PROPOSED CONSTRUCTION OF A RCC ROOF RESIDENTIAL BUILDING AT VAZHAVILAKOM IN RE.SY.NO.350/1A,1B OF KULAPPURAM VILLAGE, METHUKUMMAL PANCHAYATH,KILLIYOOR TALUK KANYAKUMARI DISTRICT.

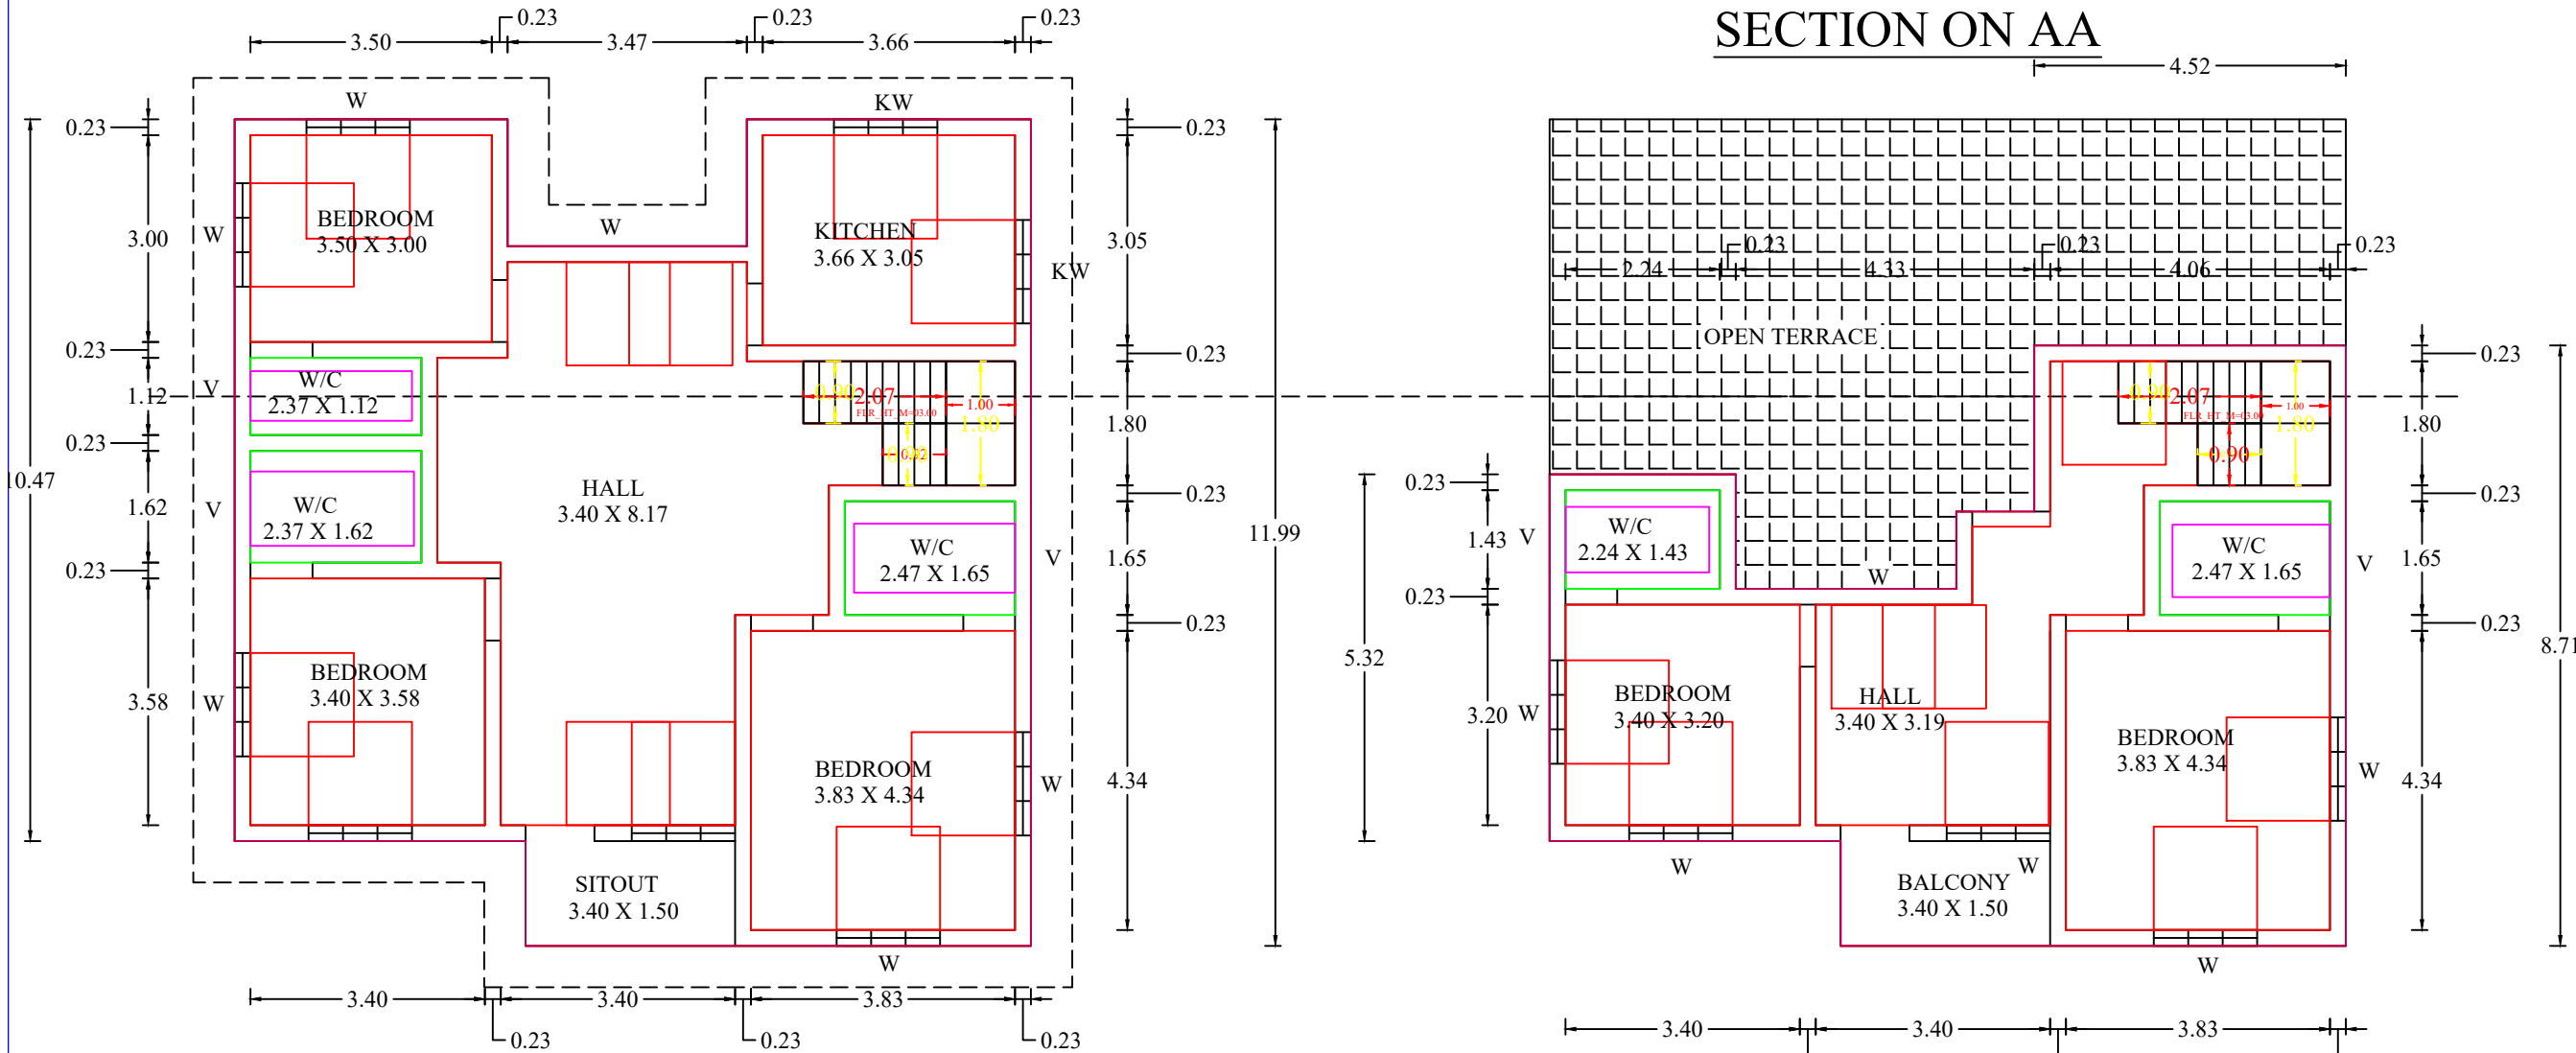
GROUND FLOOR

PLINTH AREA :125.68 Sq.m (or) 1352.31 Sq.ft  
FLOOR AREA :115.26 Sq.m (or) 1240.19 Sq.ft

FIRST FLOOR

PLINTH AREA :75.11 Sq.m (or) 808.18 Sq.ft  
FLOOR AREA :66.27 Sq.m (or) 713.06 Sq.ft

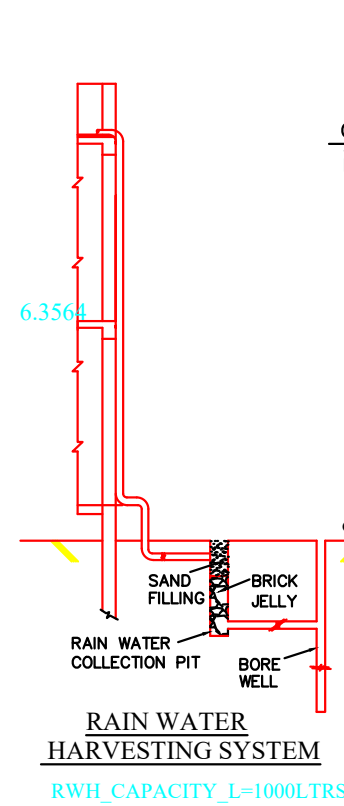
RAIN WATER  
HARVESTING SYSTEM  
RWH\_CAPACITY\_L=1000LTRS
