# Planning Permission

**Building Plan**

PLAN SHOWING THE PROPOSED CONSTRUCTION OF R.C.C.TERRACED GROUND FLOOR, FIRST FLOOR & SECOND FLOOR RESIDENTIAL BUILDING IN OLD SURVEY No:89/2, NEW PATTa No:357 & 5553, NEW SURVEY No:89/47A2A & 89/47A2B, PLOT No:20, 21, 46 & 47, AT THUMMACHINNAMPATTI VILLAGE, THUMMACHINNAMPATTI PANCHAYAT, THIRUCHULI PANCHAYAT UNION, ARUPPUKOTTAI TALUK, VIRUDHUNAGAR DISTRICT.

NAME OF THE OWNER:Mr.M.SOLAICHAMY, S/o. Mr.MARIMUTHU,  
VIDE REGULARIZATION No:ந.க.எண்:1/873/2026, DATED:04/07/2026

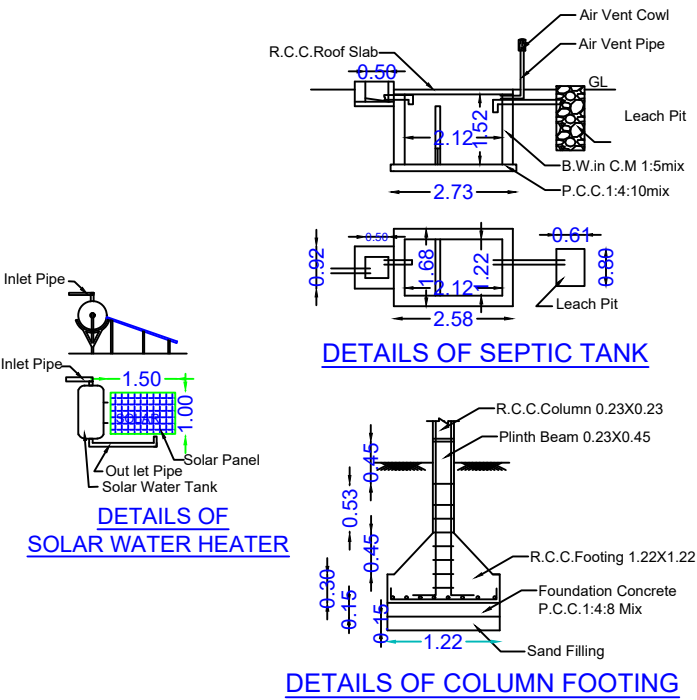
DETAILS OF SEPTIC TANK

DETAILS OF SOLAR WATER HEATER

DETAILS OF COLUMN FOOTING  
(SCALE 1:50)

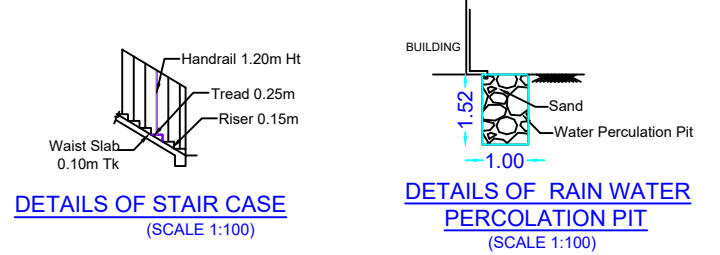
DETAILS OF STAIR CASE  
(SCALE 1:100)

DETAILS OF RAIN WATER PERCOLATION PIT  
(SCALE 1:100)
